Medical Devices: The Therac-25*

Nancy Leveson
University of Washington

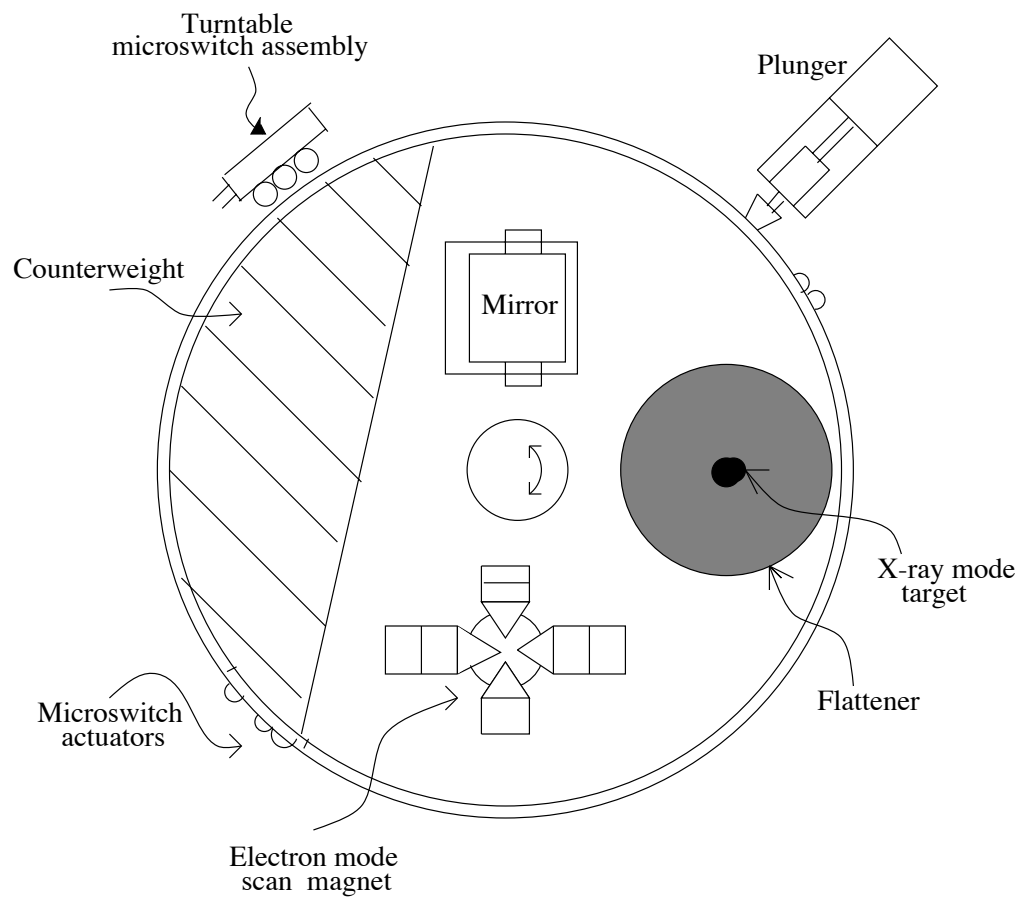
Figure 1: Upper turntable assembly.

Turntable Positioning. The Therac-25 turntable design plays an important role in the accidents. The upper turntable (see Figure 1) rotates accessory equipment into the beam path to produce two therapeutic modes: electron mode and photon mode. A third position (called the field light position) involves no beam at all, but rather is used to facilitate correct positioning of the patient. Because the accessories appropriate to each mode

are physically attached to the turntable, proper operation of the Therac-25 is heavily dependent on the turntable position, which is monitored by three microswitches.

AECL could not reproduce the malfunction that had occurred, but suspected a transient failure in the microswitch used to determine the turntable position. During the investigation of the accident, AECL hardwired the error conditions they assumed were necessary for the malfunction and, as a result, found some turntable positioning design weaknesses and potential mechanical problems.

The computer senses and controls turntable position by reading a 3-bit signal about the status of three microswitches in the turntable switch assembly. Essentially, AECL determined that a 1-bit error in the microswitch codes (which could be caused by a single open-circuit fault on the switch lines) could produce an ambiguous position message to the computer. The problem was exacerbated by the design of the mechanism that extends a plunger to lock the turntable when it is in one of the three cardinal positions: The plunger could be extended when the turntable was way out of position, thus giving a second false position indication. AECL devised a method to indicate turntable position that tolerated a 1-bit error so that the code would still unambiguously reveal correct position with any one microswitch failure.

The modifications specified in the Symonds report included redesigning the microswitch and changing the way the computer handled malfunction conditions. In particular, treatment was to be terminated in the event of a dose-rate malfunction, giving a treatment “suspend.” This change would have removed the option to proceed simply by pressing the \textcircled{P} key. The report also made recommendations regarding collimator test procedures and message and command formats. A November 8, 1985 letter, signed by the director of the Canadian RPB, asked that AECL make changes to the Therac-25 based on the Symond’s report “to be in compliance with the RED act.”

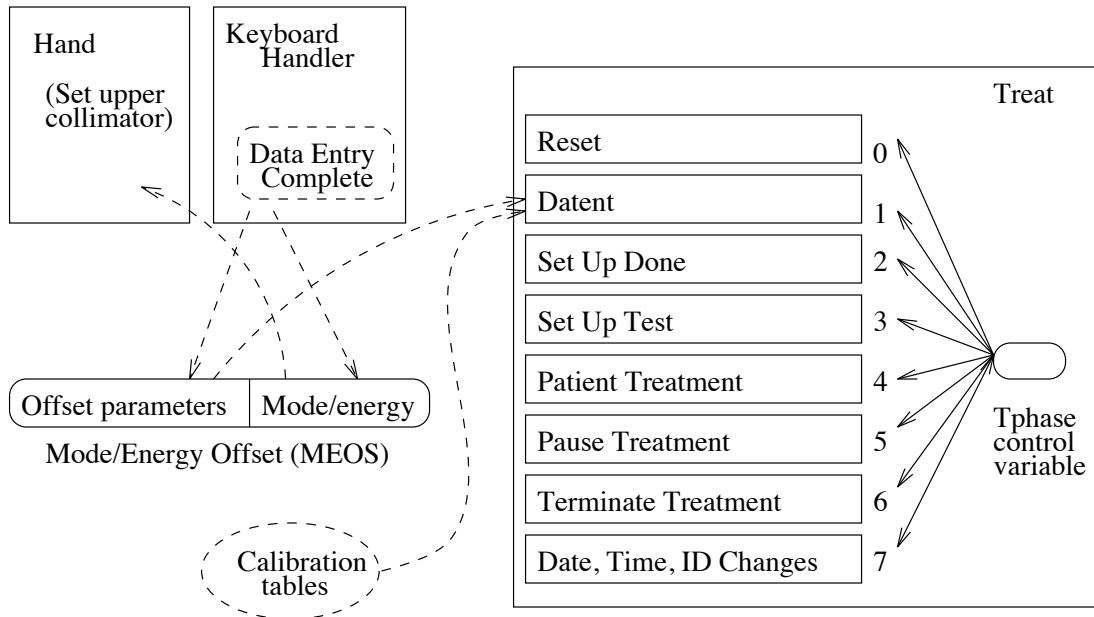
Figure 3: Tasks and subroutines in the code blamed for the Tyler accidents.

The treatment monitor task (Treat) controls the various phases of treatment by executing its eight subroutines. The treatment phase indicator variable (Tphase) is used to determine which subroutine should be executed (Figure 3). Following the execution of a particular subroutine, Treat reschedules itself.

But this is not the only problem. Upon exit from the Magnet subroutine, the data entry subroutine (Datent) checks the Data Entry Complete variable. If it indicates that data entry is complete, Datent sets Tphase to 3 and Datent is not entered again. If it is not set, Datent leaves Tphase unchanged, which means it will eventually be rescheduled. But the Data Entry Complete variable only indicates that the cursor has been down to the command line, not that it is still there. A potential race condition is set up. To fix this, AECL introduced another shared variable controlled by the keyboard handler task that indicates the cursor is not positioned on the command line. If this variable is set, then prescription entry is still in progress and the value of Tphase is left unchanged.

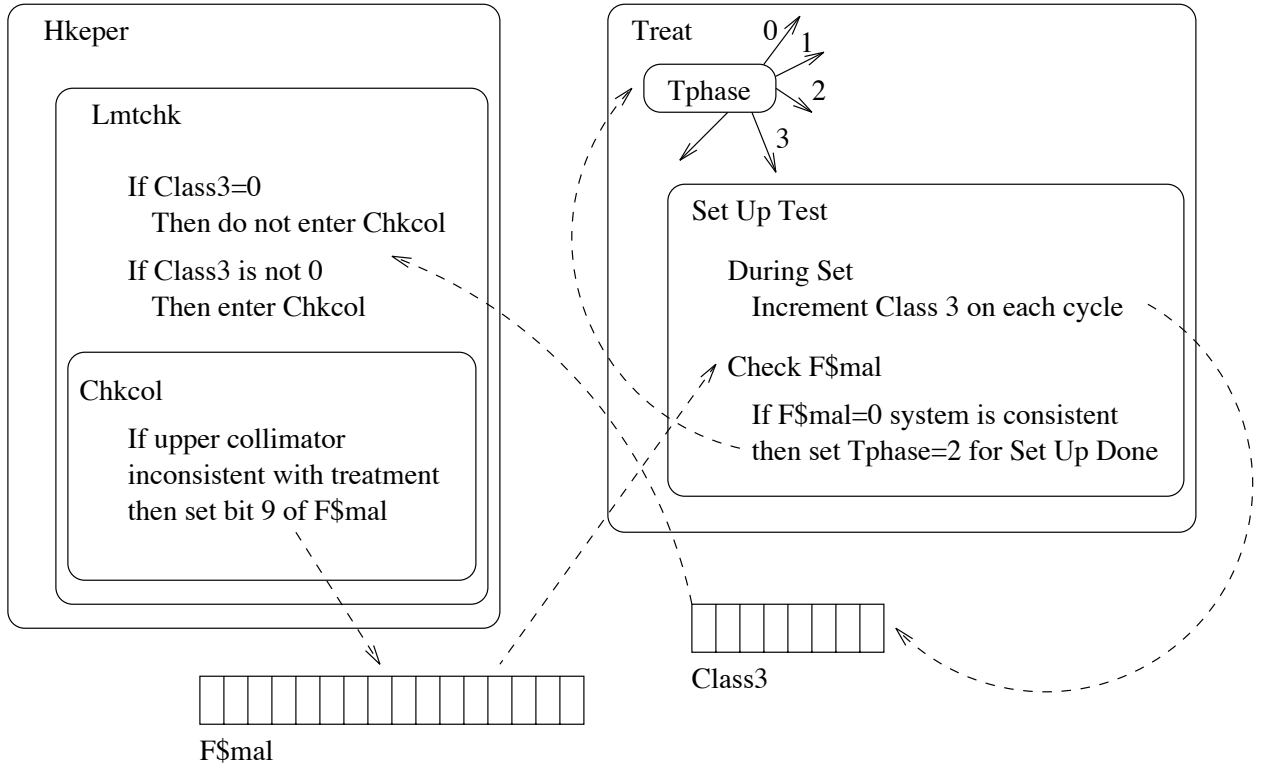
Figure 4: The Yakima software flaw.

The second Yakima accident was again attributed to a type of race condition in the software — this one allowed the device to be activated in an error setting (a “failure” of a software interlock). The Tyler accidents were related to problems in the data-entry routines that allowed the code to proceed to Set Up Test before the full prescription had been entered and acted upon. The Yakima accident involved problems encountered later in the logic after the treatment monitor Treat reaches Set Up Test.

The overexposure occurred when the operator hit the “set” button at the precise moment that Class3 rolled over to zero. Thus, Chkcol was not executed and F\$mal was not set to indicate that the upper collimator was still in the field-light position. The software turned on the full 25 MeV without the target in place and without scanning. A highly concentrated electron beam resulted, which was scattered and deflected by the stainless
